**43rd Turbomachinery
30th Pump SYMPOSIA**

INVESTIGATION AND ANALYSIS OF HIGH THRUST BEARING TEMPERATURE AFTER FIELD OVERHAUL AND RERATE OF A CENTRIFUGAL COMPRESSOR

CASE STUDY 2014 TAMU TURBO SYMPOSIUM

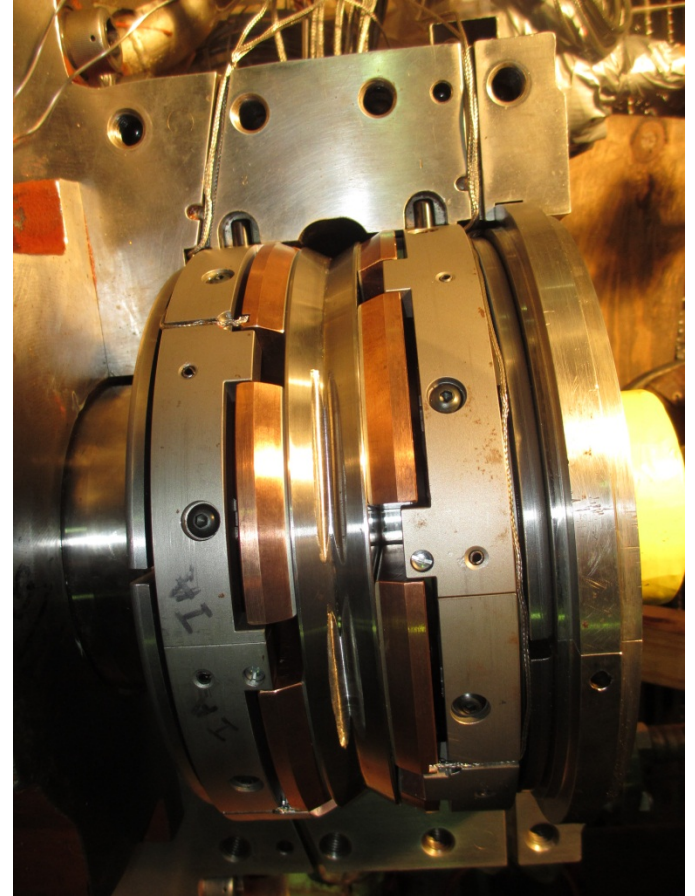
- A centrifugal compressor in ethylene plant charge gas service experienced high thrust bearing temperatures after startup from an overhaul and rerate
- The pad metal temperatures reached 265°F with a 40°F spread between instrumented pads
- Pad metal temperature would have been higher, but compressor speed was limited to avoid exceeding 265°F limit
- This speed limit imposed significant production losses. ...At times limiting the plant to 75% of its nameplate capability

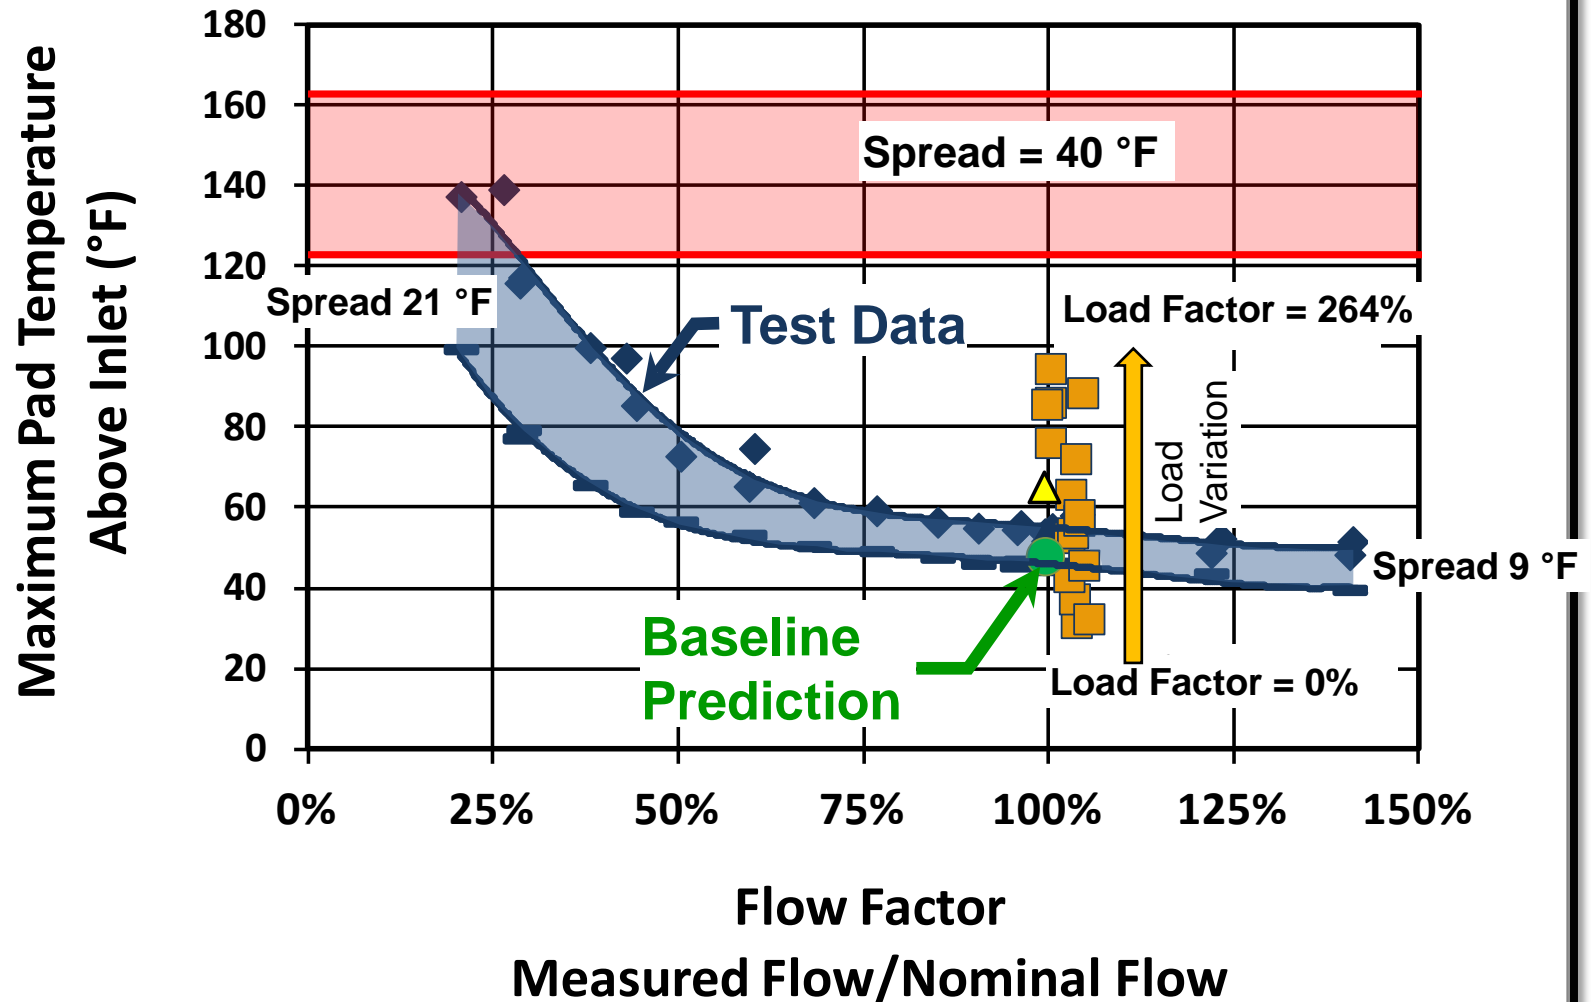
Laboratory Test Data

- The original thrust bearing design is **robust and suitable** for the application parameters
- A '**feasible**' load does **not** cause temperatures as high as the ones measured in the field
- A **severe lack of oil**, compared to design, can result in excessive pad temperatures
 - Possibilities: internal bypass, leak, or obstruction
 - Thrust cavity was no longer “flooded” resulting in a large pad temperature spread due to varying degrees of pad oil starvation around the bearing
- Focus for the field troubleshooting effort should be placed on the **oil supply** to the thrust bearings

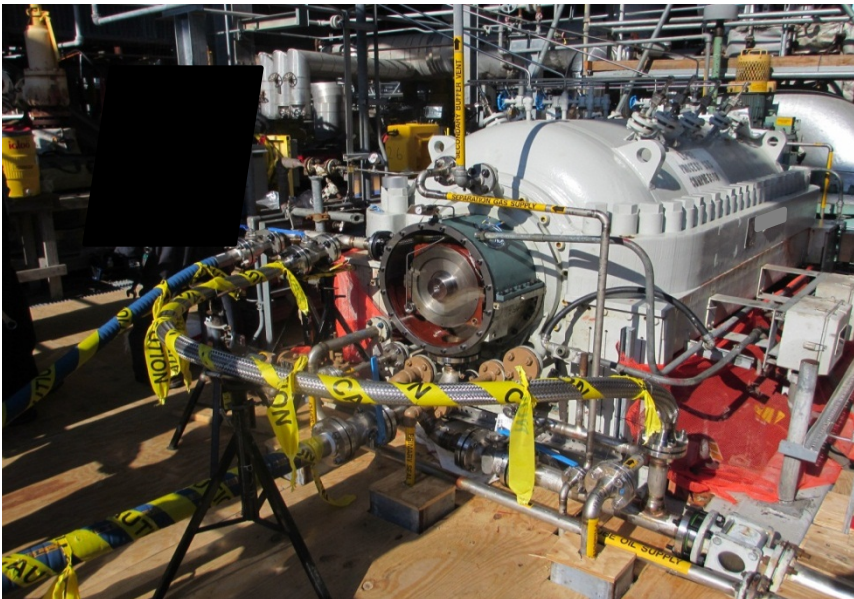
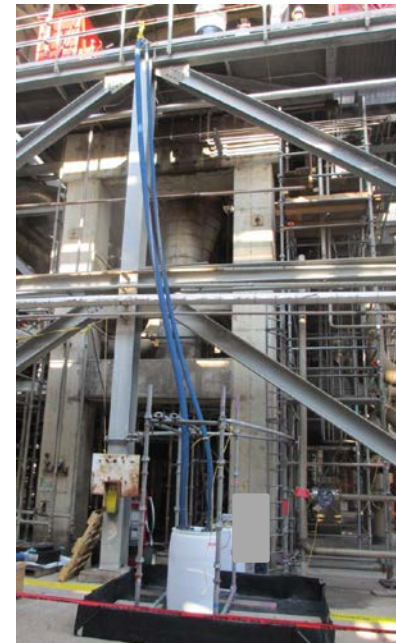
Low Oil Flow Due to Orifice Position

- Radial bearing metering orifice found in thrust position (15/64" compared to 27/64" design)
- Suspect pipe plug orifices were swapped when rebuilding during turn around overhaul
- Field oil flow testing matched test stand data, confirming root cause
- Post rebuild oil flow test confirmed that design flow had been restored to the radial bearing and had been properly applied to the retrofitted directed lube bearing

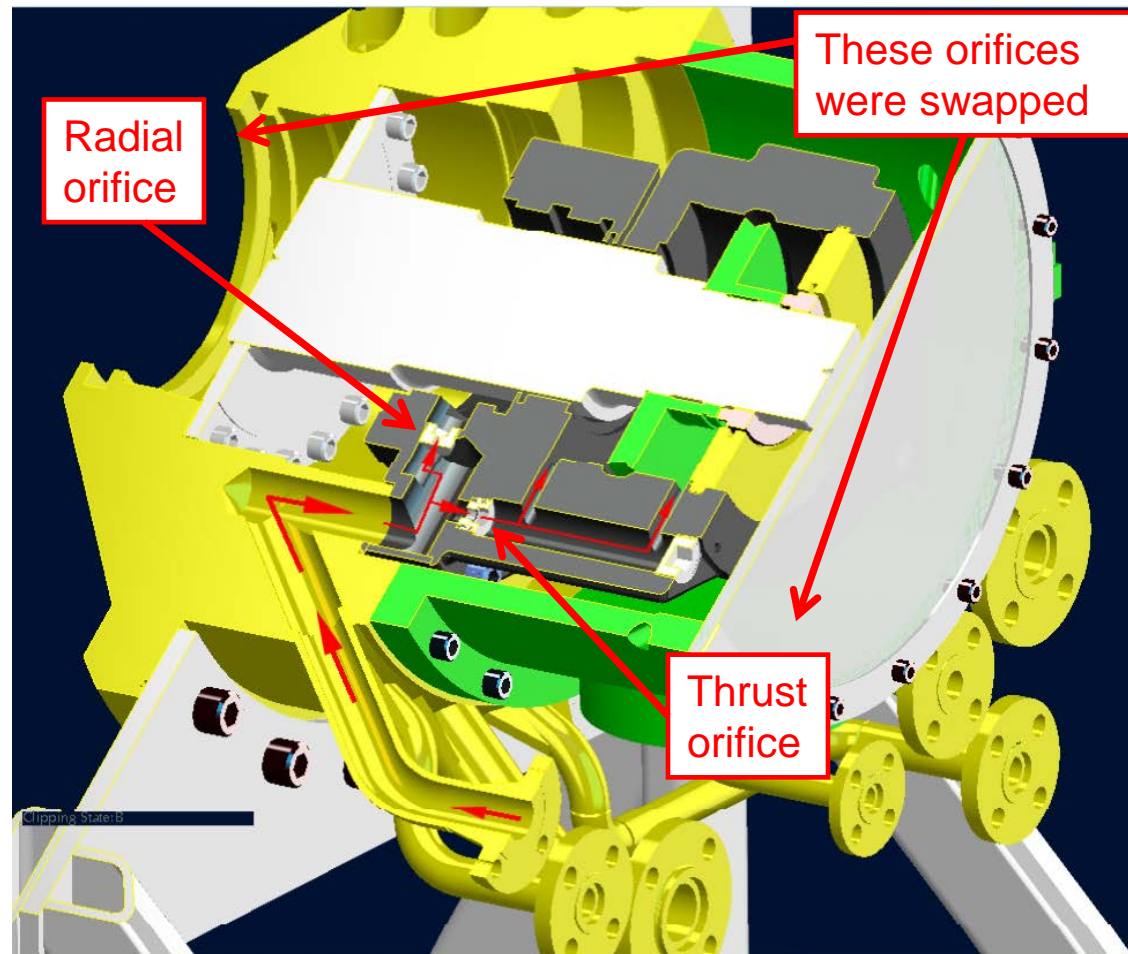
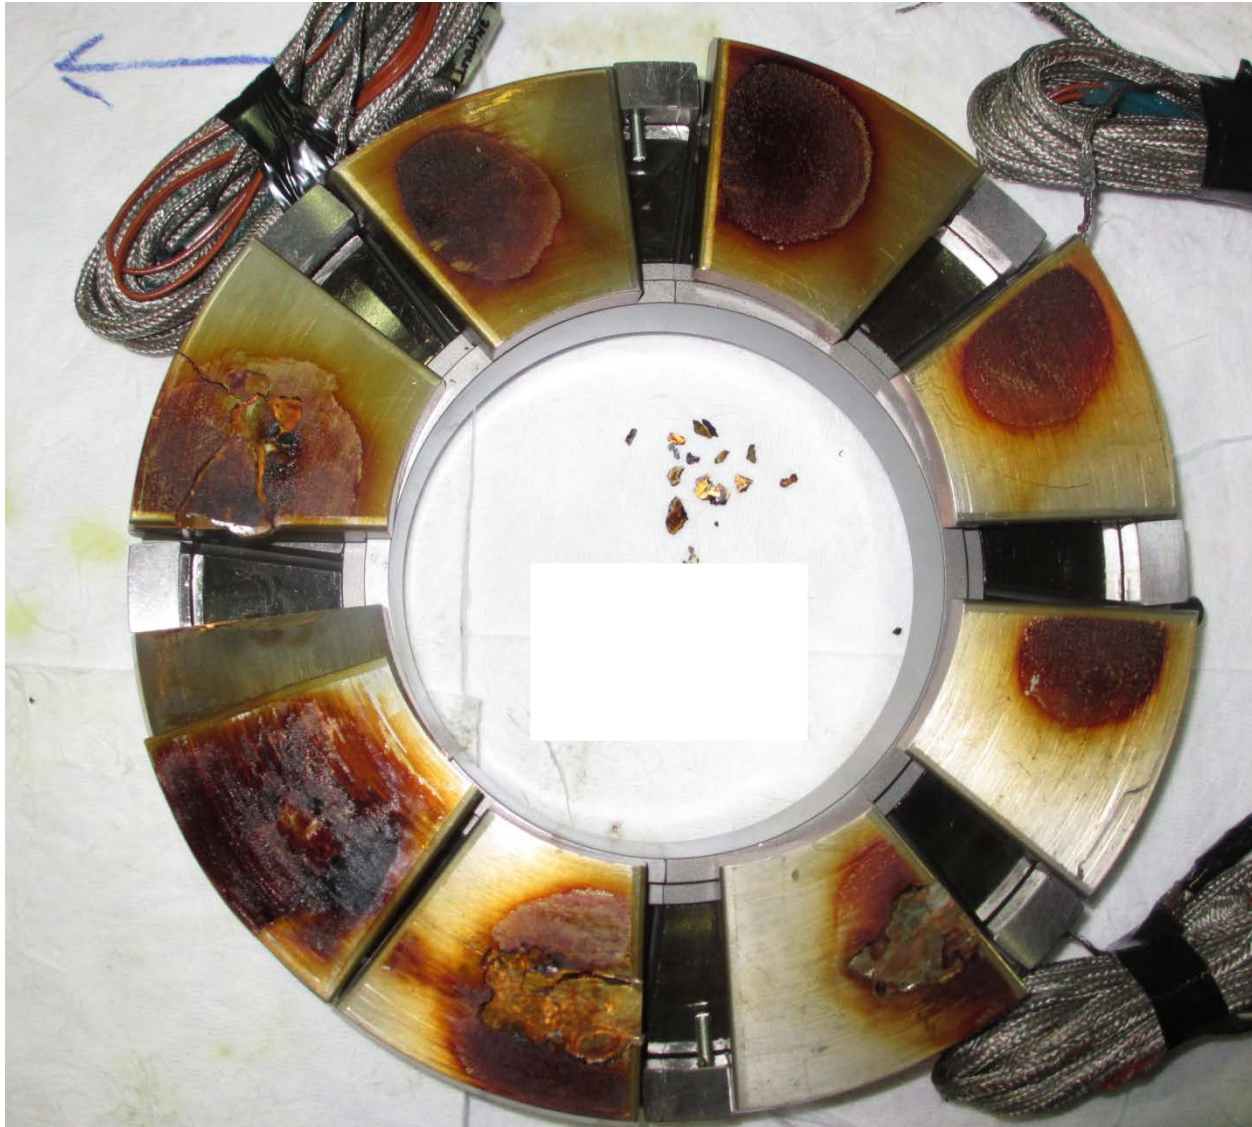
Bearing damage

- Most severe damage to pads in region of the “hottest oil” in farthest clock position from oil the inlet
- Babbitt delamination noted
- Likely compounded performance problem, especially at late stages of the run
- Inactive bearing was pristine
